# Test Report

No.: 64.190.23.0479.01-00

**Sample Submission:** The sample was submitted by applicant and identified.  
**Product Name:** Aluminum truss  
**Order No.:** /  
**Identification/Style No.:** TS-300P  
**Manufacturer:** EVENT-BROTHER(FOSHAN)STAGING EQUIPMENT MANUFACTURING CO.,LTD  
**Country of Origin:** China  
**Buyer:** /  
**Export to:** /  
**Receipt Date of Sample:** 2023-08-16  
**Date of Testing:** From 2023-08-16 to 2023-08-16  
**Test Result:** Refer to the data listed in following pages

1. Loading test according to client's requirements

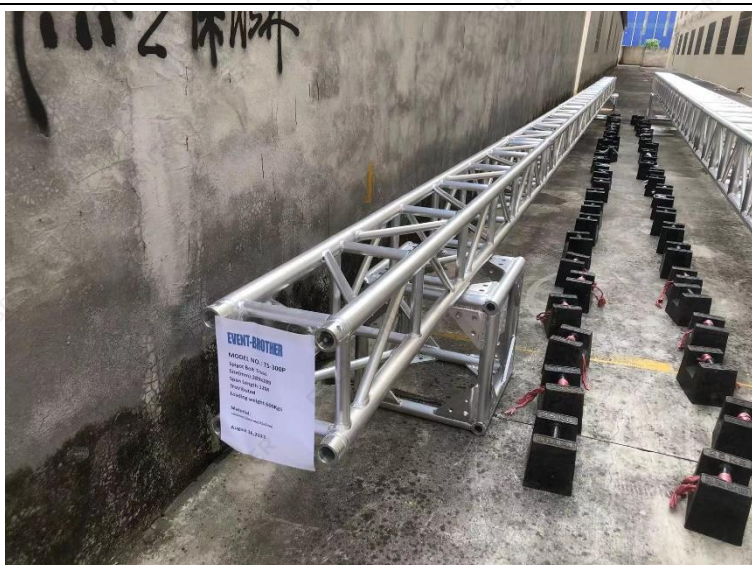
## Sample photo(s)

1	Product Description	Aluminum truss	
2	Dimensions	Overall Dimension:	15m L x 289mm W x 289mm H
		Main tube (mm):	Dia. 50 x T 3.0
		Vice tube (mm):	Dia. 30 x T 2.0
		Brace tube (mm):	Dia. 25 x T 2.0

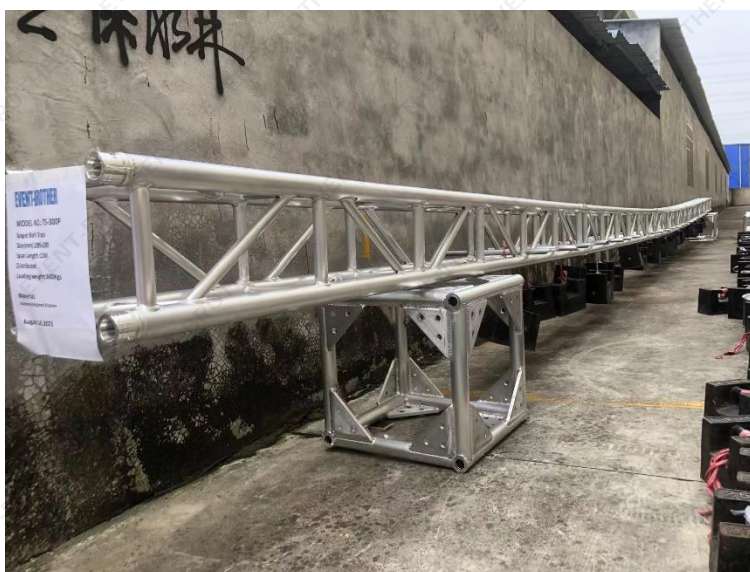
## TESTING PHOTO

Test item	Requirement ~ Test	Measuring result ~ Remark	Verdict
Loading test	<p>The nominal loads were applied and the deflections were measured.                      Uniformly distributed load (UDL)                      The truss was supported by two rigid frames at two ends to reach a certain span tested according to Figure 1.                      Then the specified nominal load was uniformly distributed on the truss.                      Measured the deflection under this loading condition.                      Check if any damage during and after test.</p>

Item	Test Data										
	Span, (m)	12									
Uniformly distributed load, (kg)	600										
Loading point	1	2	3	4	5	6	7	8	9	10	11
Distance from bottom of truss to the ground prior to Test, (mm)	565	574	567	568	556	559	565	570	569	573	575
Distance from bottom of truss to the ground in loading Test, (mm)	539	521	491	480	467	460	474	482	500	520	545
Measured deflection, (mm)	26	53	76	88	89	99	91	88	69	53	30
Test results	No visible damage was found during and after test.

Span, (m)	Uniformly distributed load, (kg)	Central deflection, (mm)
12	600	99
