**Test Report** No.: 64.190.23.0909.01-00

**Product Name:** Aluminium stage

Identification/Style No.: STA-02S

Loading test according to client's requirements

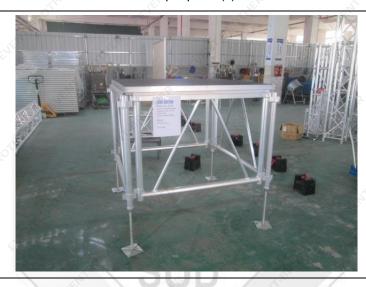
## Sample photo(s)

1	Product Description	Aluminium stage	
2	Dimensions	Overall Dimension:	1.22m L x 1.22m W x 1.3m H
JEN	BRD LIFE LANTIBROTT	Frame & transom:	Aluminum Transom&steel layer truss
	of Broth	Frame (mm):	Dia. 50 x T 3.0& Dia. 25 x T 2.0
	Energy Strate	Leg profiles:	Dia. 50 x T 4.0

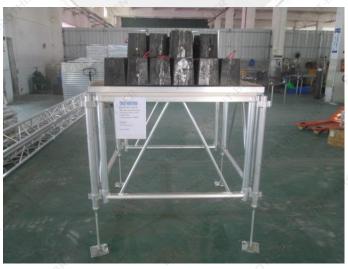
#### **TESTING PHOTO**

Test item	Requirement ~ Test	Measuring result ~ Remark	Verdict
Loading test	The specified loads were applied and observe any damage under this loading condition.	Details see the following appendix 1	1 ROTHER
	Uniformly distributed load (UDL)     The stage was supported by four poles at four ends.     A specified nominal load was uniformly distributed on the stage according to Figure 1.	SAFALIBEOLIHES SOLHER	S.
		ENEMI SEE	9-
	Figure 1	K. Hitigh

Item	Test Data	
Surface Area, (m²)	1.48	
Uniformly distributed load, (kg)	1000	
Test results	No visible damage was found during and after test.
